## st mary's church, kingswood

### quinquennial inspection report number 1

17<sup>th</sup> August 2017

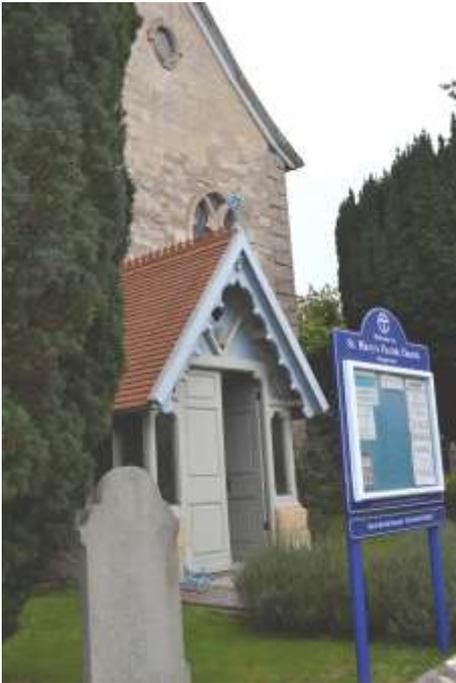
The west porch is in sound condition but paintwork is beginning to deteriorate. Redecoration and minor masonry repointing to the plinth is recommended during the quinquennium.

West porch.

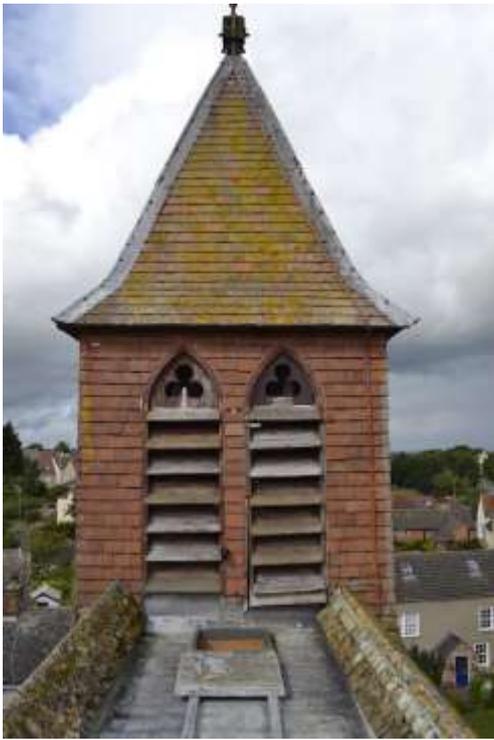
The condition of the bellcote should be monitored, the lead hips are nailed in place and ideally should be replaced. The stone work to the earlier bell turret is damaged by rusting ironwork. The louvred door to the bellcote needs some overhaul and some alteration is required to ensure the bell wire does not continue to damage the stone. Some repair in the medium to long term should be anticipated. Restoration of the clock mechanism should also be considered.

Bellcote east side.

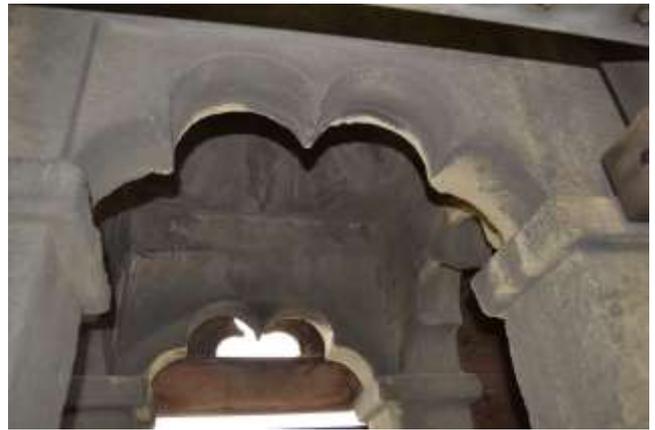
The earlier stone turret is suffering with iron cramp damage, several fractures are visible at the base and the stone roof.

Interior of bellcote with earlier stone bell turret.

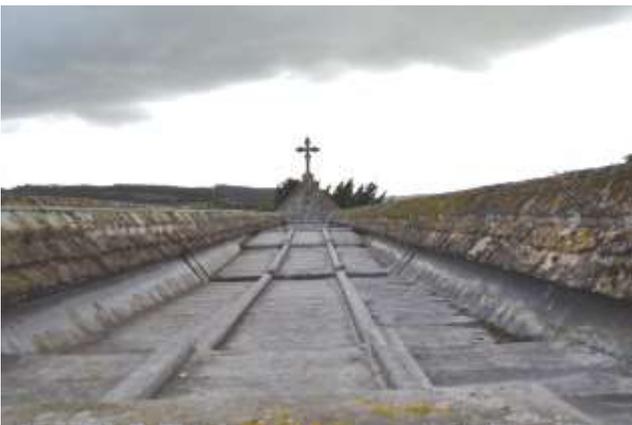
The lead valley is old, but generally in a satisfactory condition. There is damage to one bay which has been repaired with flashband.

Lead ridge valley looking east.

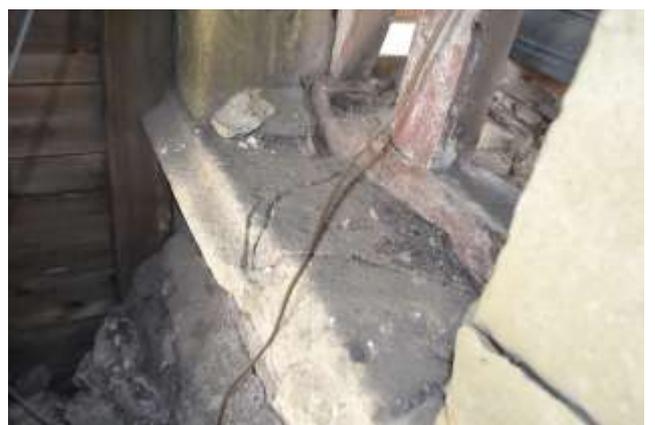
Stone decay to interior of bellcote.

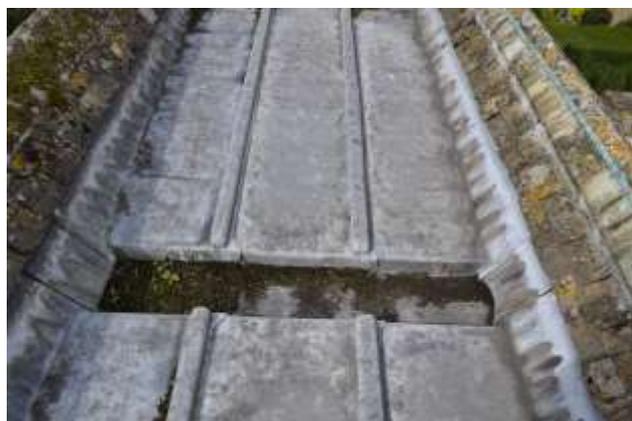
The gutter has two outlets, to the north and south, there was some build-up of silt. Some decay to flashing at the east end. Ridge tiles to each side of the gutter have been reset and look to be in sound condition.

Outlet to nave ridge valley.

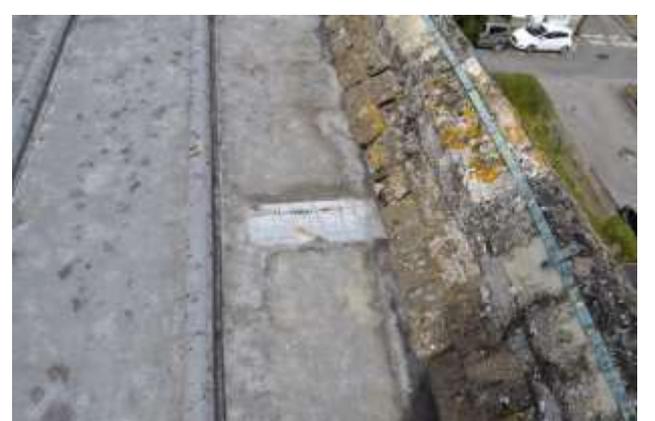
Flashband repair to lead on ridge valley.

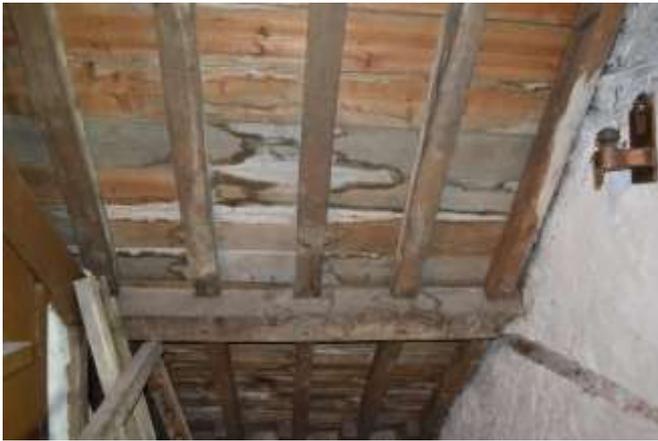
Nave and Chancel is rafter and purlin roof with sarking boards supported by trusses. The roof structure is largely concealed by the barrel vaulted ceiling structure and is only visible at the west end nave. Some evidence of water ingress is visible on the sarking boards on the south side. This appears to be historic, but could indicate a leak at the abutment with the Bellcote and should be monitored during wet weather.

Historic water ingress visible on roof timbers.

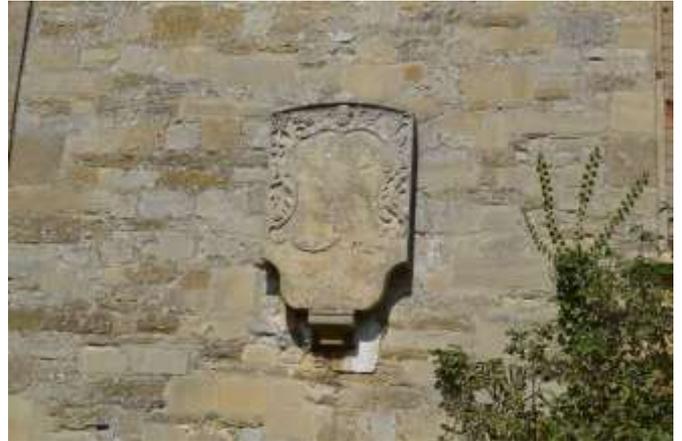
Monument of south wall remnant of render.

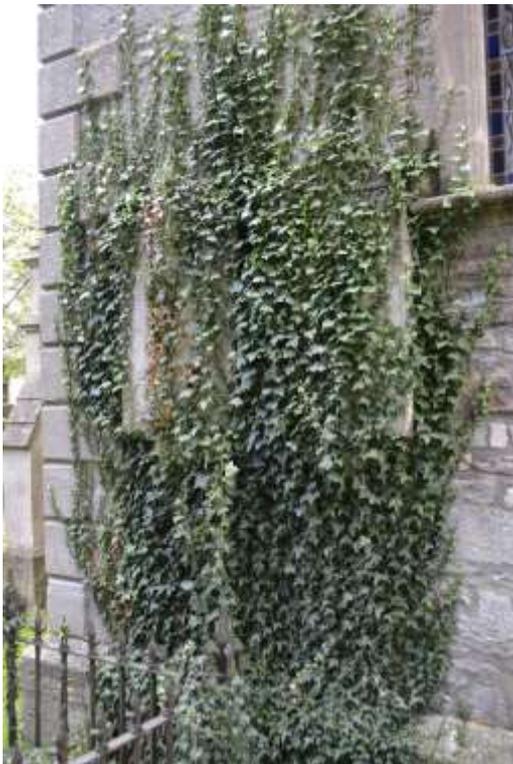
- There is an open joint to voussoir on the window to the south wall of the nave.
- Some slight movement evident in the south kneeler.
- There is extensive ivy and vegetation growth particularly on the east wall of the church and the organ loft where it is growing over the east window and wall monuments.
- On the west wall of the north transept there are areas of ribbon pointing to the plinth which is causing accelerated decay of the limestone.
- There is a fracture in the stone to the left-hand jamb to the window on the north side of the Nave.
- The walls to the Store/Boiler Room are roughcast and in poor condition and continue to deteriorate, particularly on the north side where the walls have been previously patched and repaired. There is cracking and the stone work beneath is exposed in places and is evidently in need of repair.

Vegetation on east wall of church.

- Remove vegetation from walls. **A**
- Carry out general masonry repairs, repointing open joints. Removing ribbon pointing and repoint the plinths. **B**
- Repair walls and re-render boiler room. **B**
- Monitor the condition of stone walling and consider re-rendering in a lime render in the long term. **MON/C**

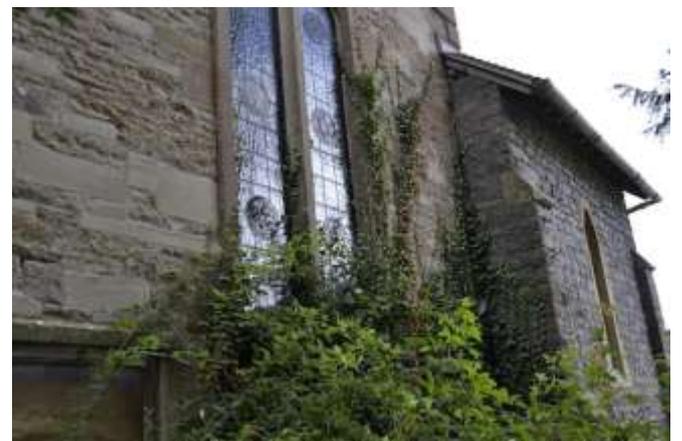
East end with overgrown vegetation.

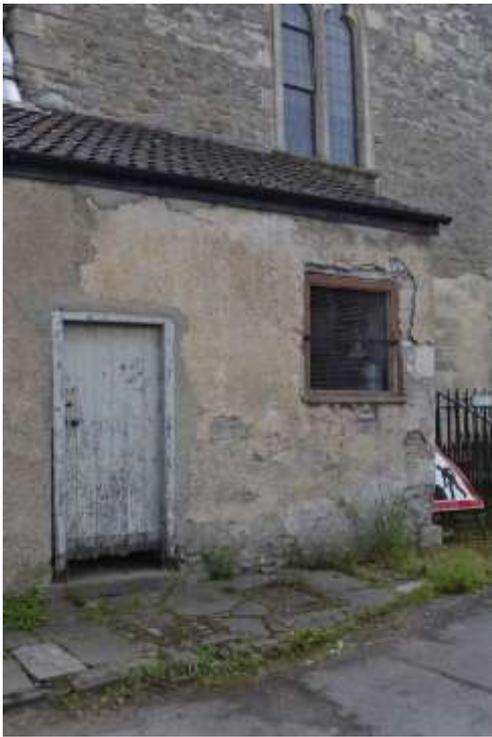
Repairs are required to the boiler room where the render is in very poor condition and the door is decayed. Maintenance and improvement of the steps and railings to the north door is also recommended, particularly as this serves as a fire exit.

The door to the boiler room store is decayed and the bottom section is lost.

Boiler house failing render and door.

Repair existing or replace timber door to the boiler room.

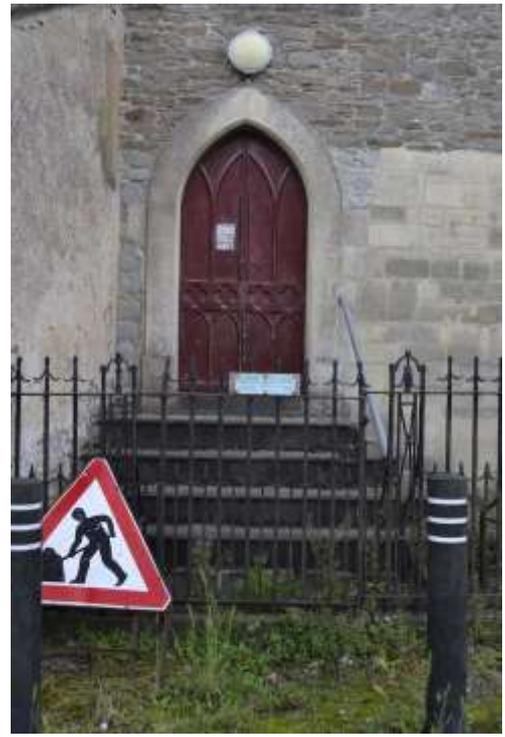
North door step and railings.

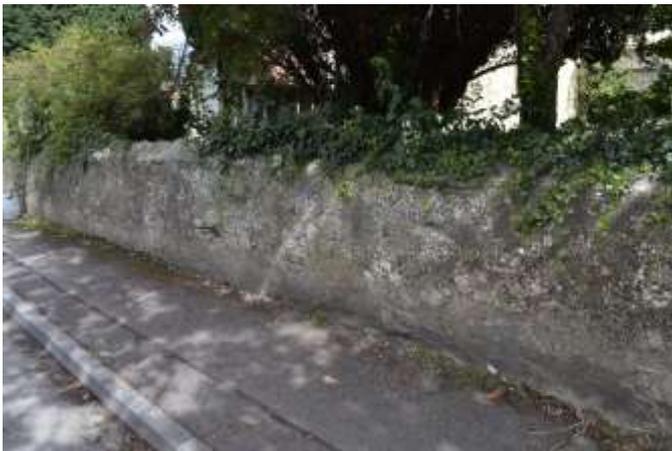
West wall is stone and has been rendered over. The render is failing badly to its whole length and there is ivy growth particularly on the roadside. Towards the south end the wall bulges outwards. The west gate is metal with limestone pillars either side. The pillars are in sound condition as is the gate but the paint surface is beginning to deteriorate.

West wall churchyard in deteriorating condition.

Carry out repairs to west boundary wall, remove ivy, dismantle and rebuild bulging sections of wall and repointing.
